Manhole Inspection Summary

Manhole # S43I__033MH

Location Address: **309 unnamed alley**

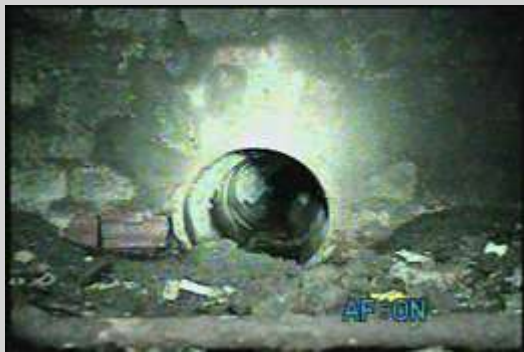
12 O'Clock Outflow

8 in. Circular Gravity Sewer
Pipe Out @ 12 O'Clock

Pipe Material: **Clay** ☐ Pipe Lined

Infiltration: **None** Pipe Seal Cond: **Unknown**
